TEST REPORT

No. 112604-001-1-a

CUSTOMER 1	SUSENSIONES ELÁSTICAS DEL NORTE, S.L. (SEÑOR)
ADDRESS	POL. IND. EL GARROTAL, PARCELA 10, MODULOS 4 Y 5 14700 PALMA DEL RIO CORDOBA SPAIN
CUSTOMER 2	SAINT-GOBAIN PLACO IBÉRICA, S.A.
ADDRESS	C/ PRÍNCIPE DE VERGARA 132, 8ª PLANTA 28002 MADRID SPAIN
PURPOSE	FIRE RESISTANCE TEST ACCORDING TO EN 1364-1:2015 FLEXIBLE PARTITION
TESTED SAMPLE (*)	Customer 1 - REF. "3PPF15+M90 LM/600+SE-9600+M90 LM/600+3PPF15" Customer 2 - REF. "3PPF15+M90 LM/600+M90 LM/600+3PPF15"
RECEPTION DATE	15.05.2024
TEST DATE	23.05.2024
ISSUE DATE	20.09.2024
TRANSLATION DATE	09.10.2024

Reference (*) **"3PPF15+M90 LM/600+SE-9600+M90 LM/600+3PPF15"**
"3PPF15+M90 LM/600+M90 LM/600+3PPF15"

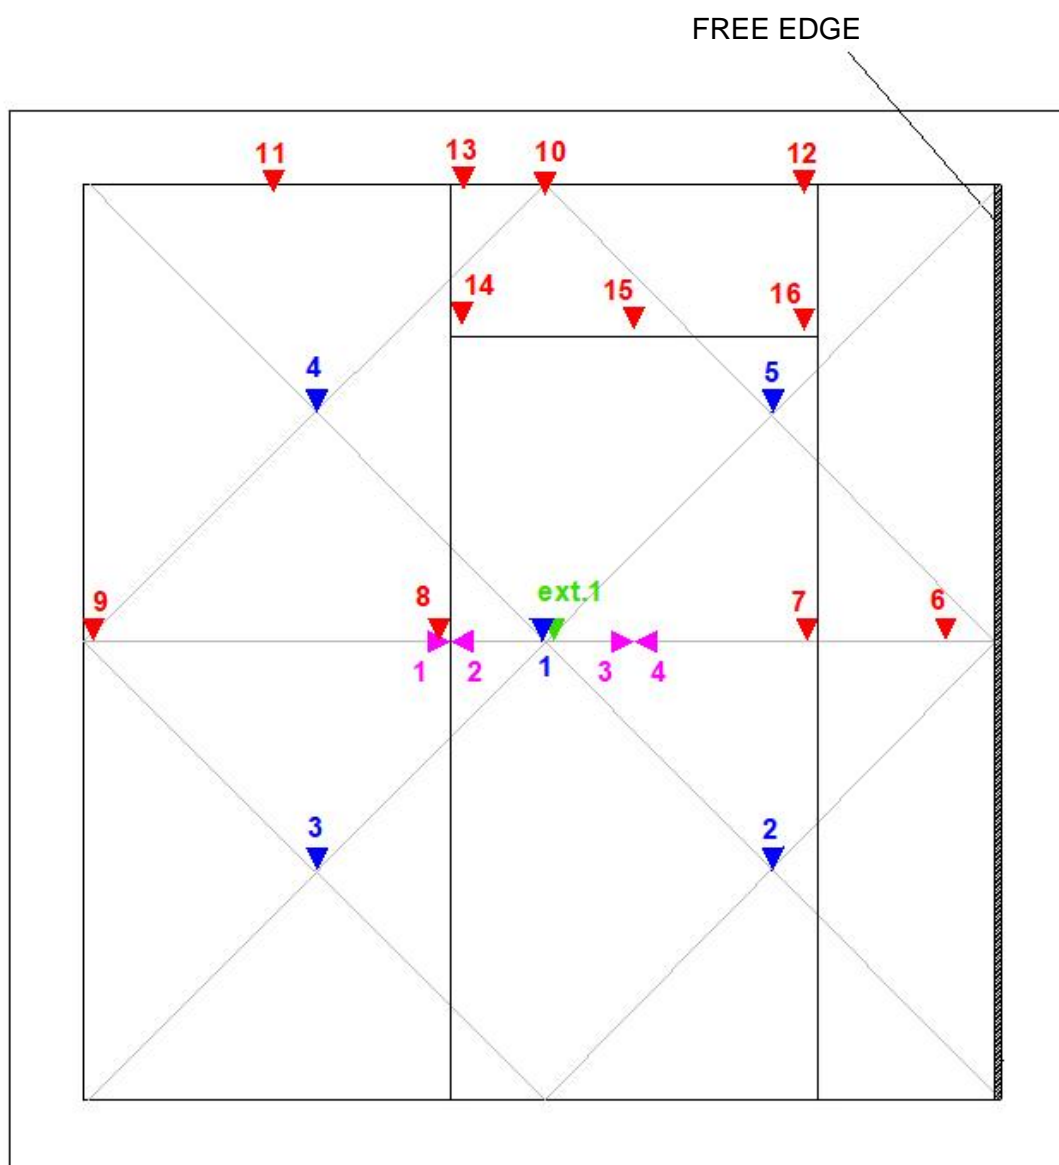
Figure 6 - Layout of the measurement equipment in the sample, thermocouples and strain gauge.

Blue: average and maximum temperature measurement thermocouples.
Red: maximum temperature measurement thermocouples.
Green: measurement of the deformation.
Purple: measurement thermocouples for EXAP.

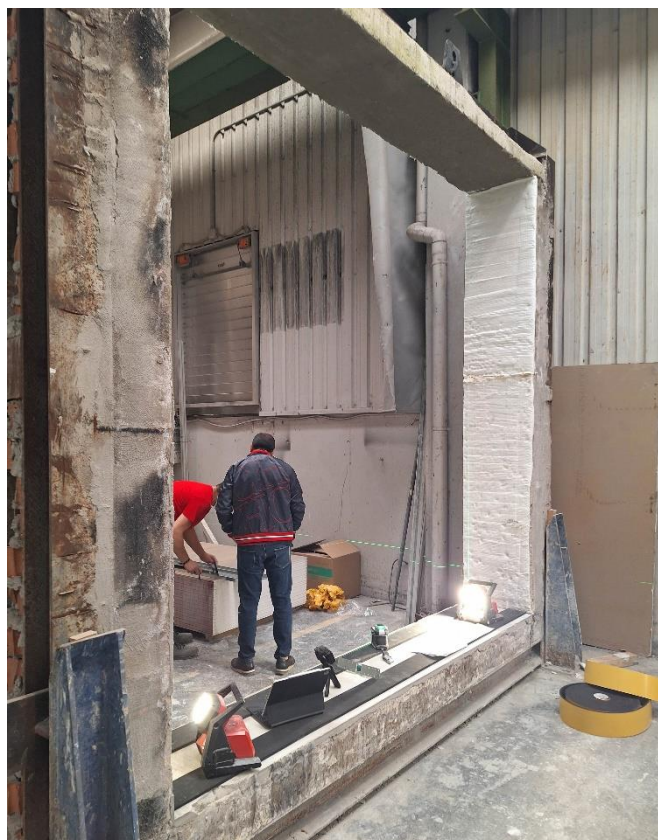
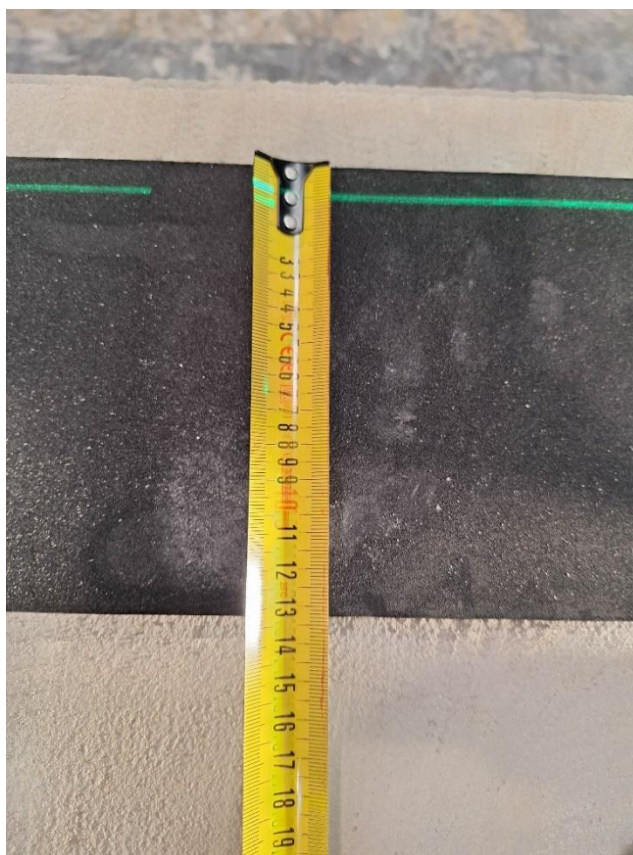
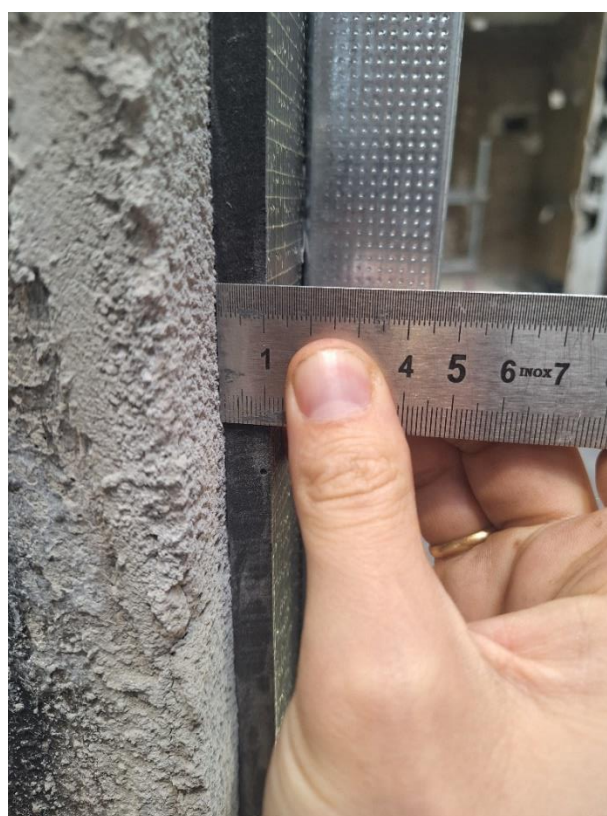
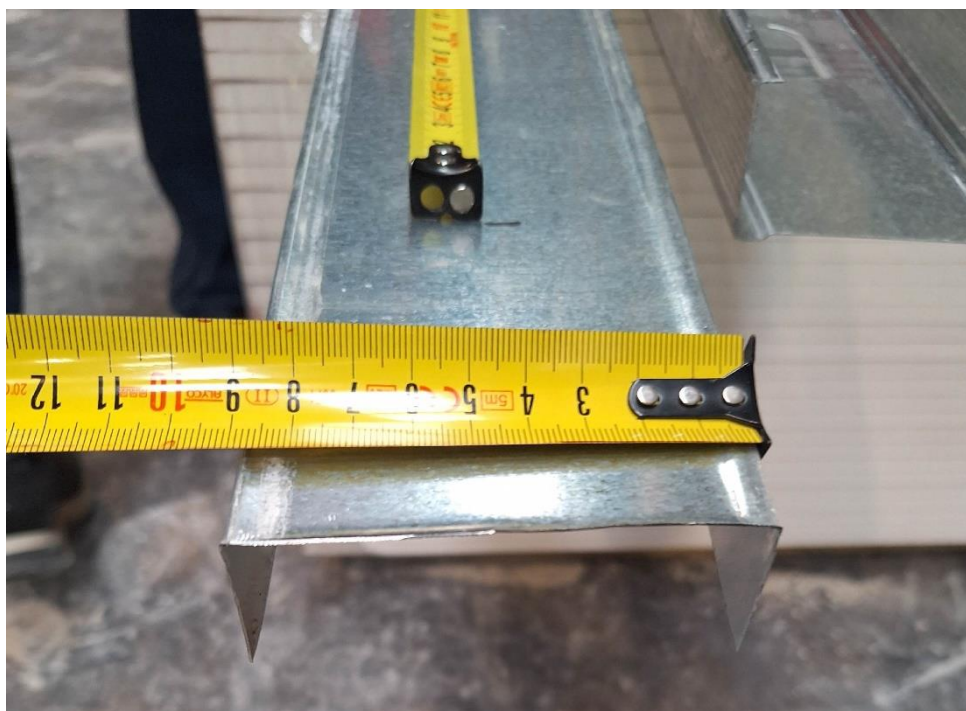
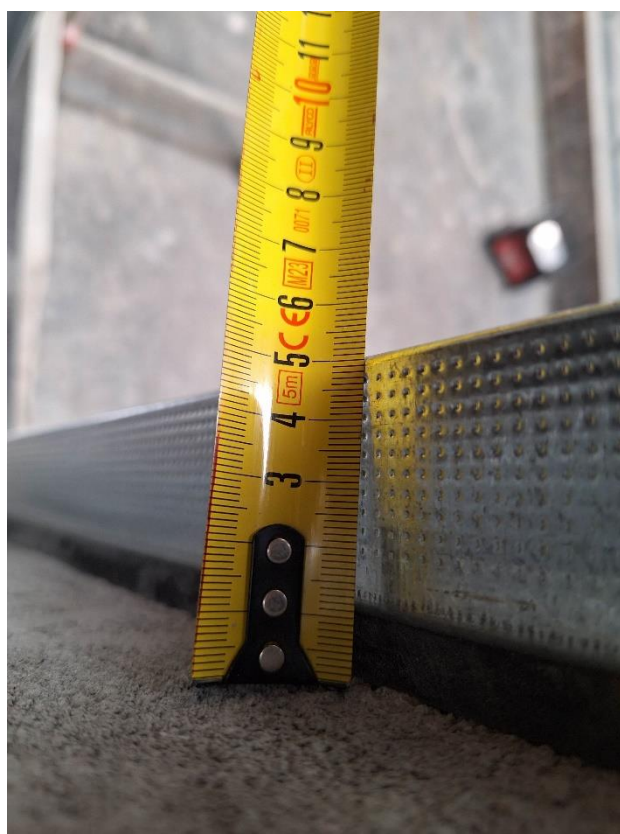
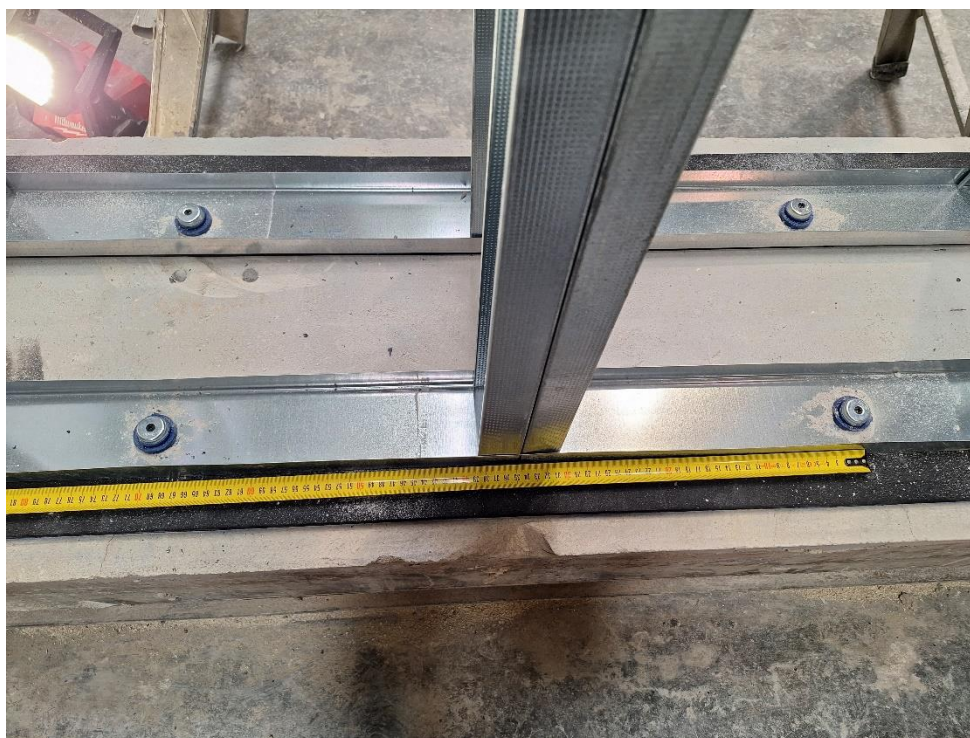
Photographs 1-27: Sample assembly.

Photographs 1-27	Sample assembly.
Photograph 28	Appearance of the sample before the test, exposed side.
Photograph 29	Appearance of the sample before the test, unexposed side.
Photographs 30-37	Appearance of the sample during the test.
Photographs 38-39	Appearance of the sample at the end of the test.
	Thermographic sequence.

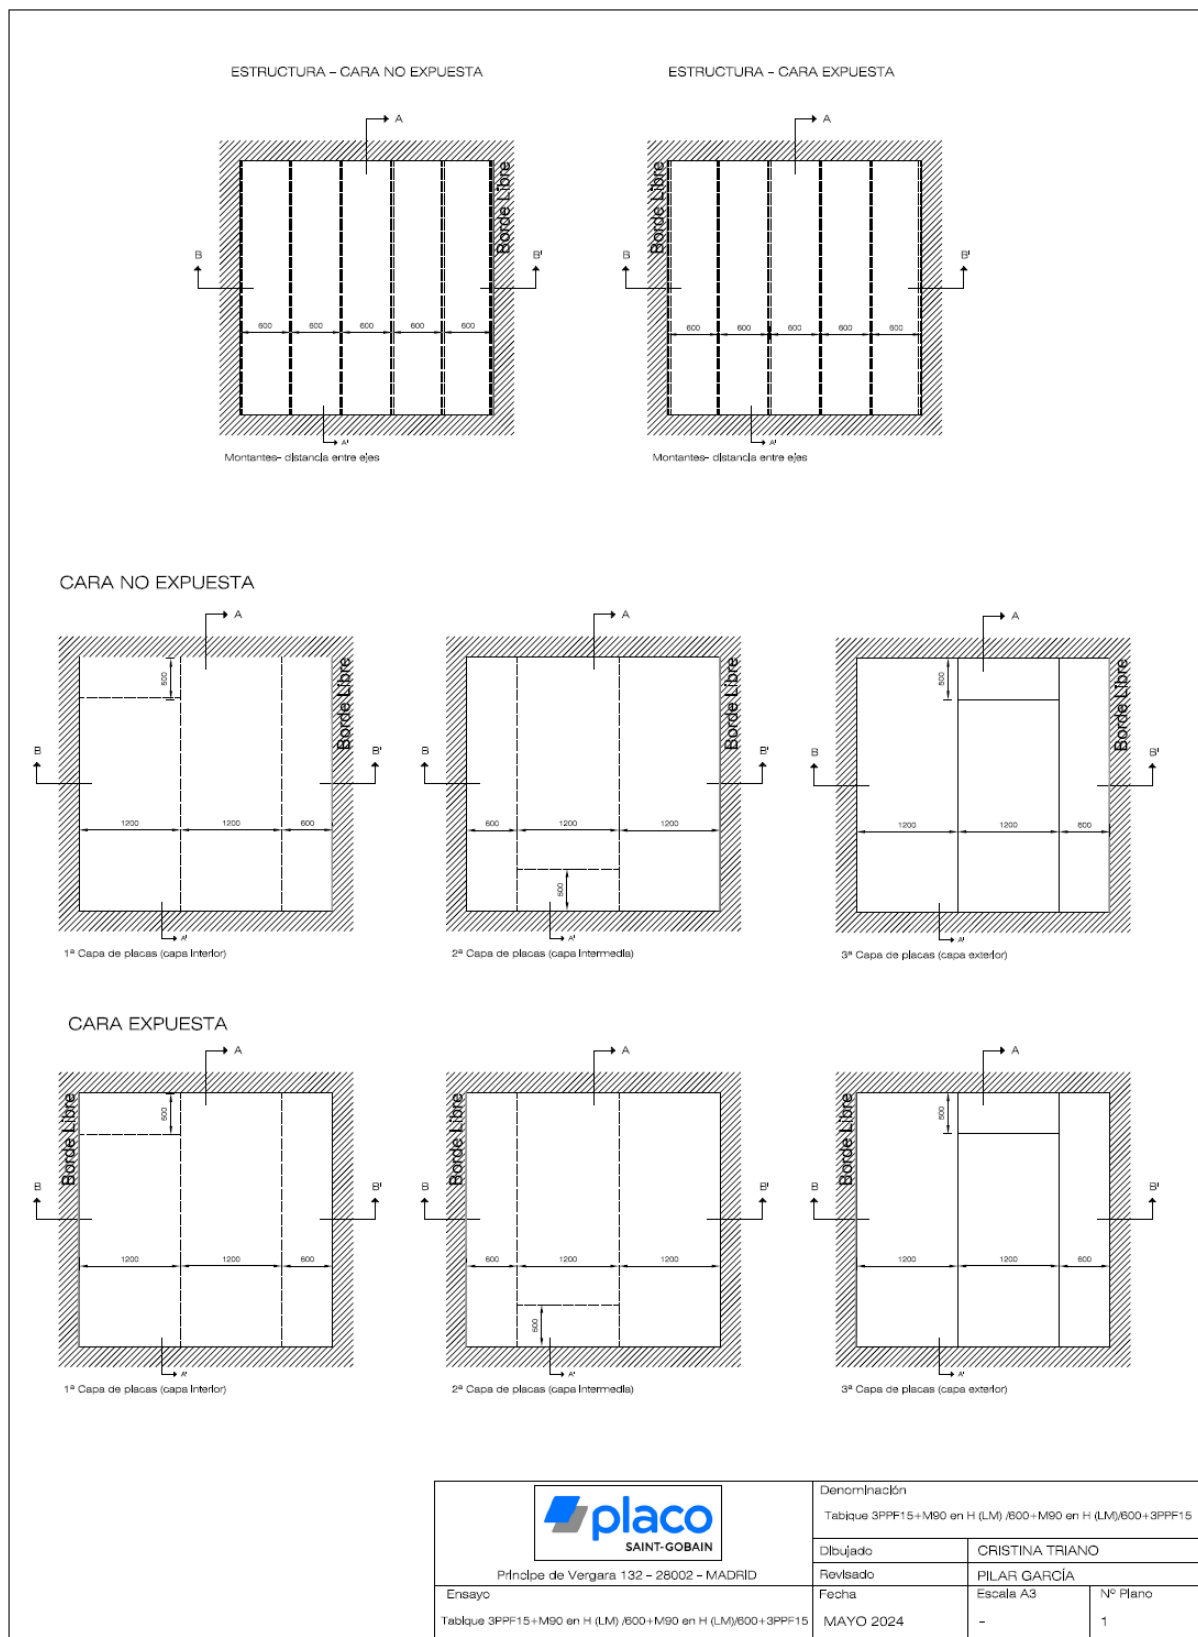
Príncipe de Vergara 132 - 28002 - MADRID	Denominación Tabique 3PPF15+M90 en H (LM) /600+M90 en H (LM)/600+3PPF15		
	Dibujado	CRISTINA TRIANO	
	Revisado	PILAR GARCÍA	
	Ensayo Tabique 3PPF15+M90 en H (LM) /600+M90 en H (LM)/600+3PPF15	Fecha MAYO 2024	Escala A3 - Nº Plano 2

- 1.- PLACA PPF 15 de 15 mm de espesor
- 2.- AISLAMIENTO ARENA APTA
- 3.- MONTANTE M-90
- 4.- RAIL R-90
- 5.- TORNILLOS TTPC 25
- 6.- TORNILLOS TTPC 45
- 7.-TORNILLOS TTPC 70
- 8.- BANDA ESTANCA
- 9.- BORDE LIBRE
